Service Bulletin

Machinery Affected: *RoofTracker™ and AutoPress 14TL™ Presses*
Document: SB194
Title: Replacing Light Bar Receiver
Applies To: *Omron STI™ Light Bar PA4600*
Distribution: Customers, All With PA4600 Light Bars in Date Range

Item # and Rev.	SB194
Date Created	19 August 2011
Created By	R. Tucker
Reviewed by	M. Kanjee
Approved by	G. Pritchett
Applicability	Omron Light Bars series PA 4600 manufactured between 1 Jan. 2008 and 31 Dec. 2009

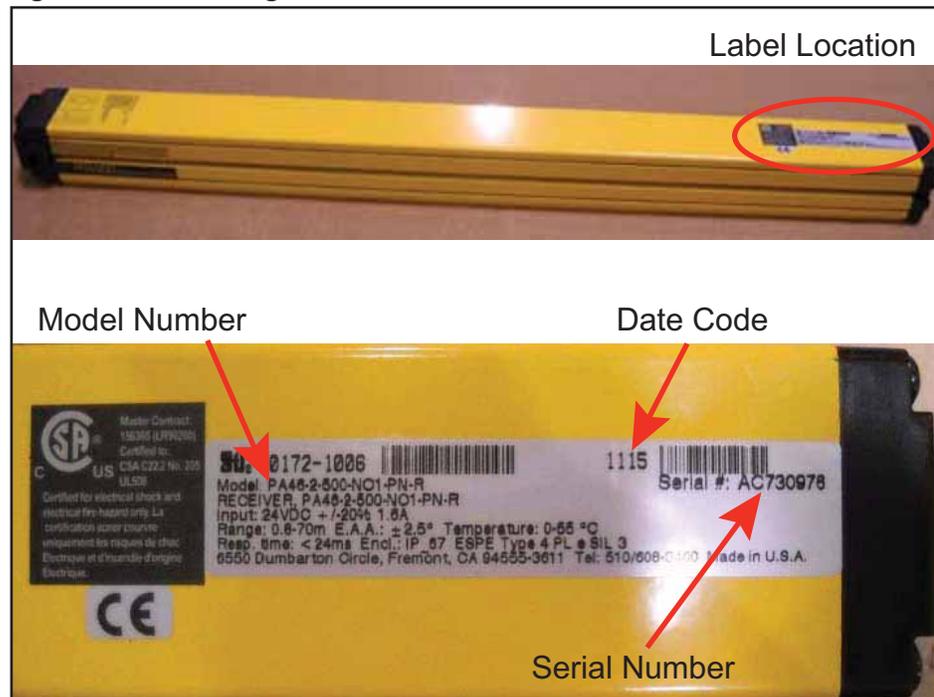
Figure 1: Determining Your Model Number

The light bars affected were manufactured between 1 January 2008 and 31 December 2009 with the model numbers listed in Table 1.

* The first 2 digits of the Date Code represents the year of manufacture.
The last 2 digits of the Date Code represents the week.
